## North Coast Regional Water Quality Control Board

**Inspection Report for June 21, 2019 Inspection**  
**Humboldt County Assessor's Parcel Number 217-381-008-000**

FILE: Cannabis Regulatory Program Inspections, John Quinn Property,  
Humboldt County, CIWQS Place ID 844276

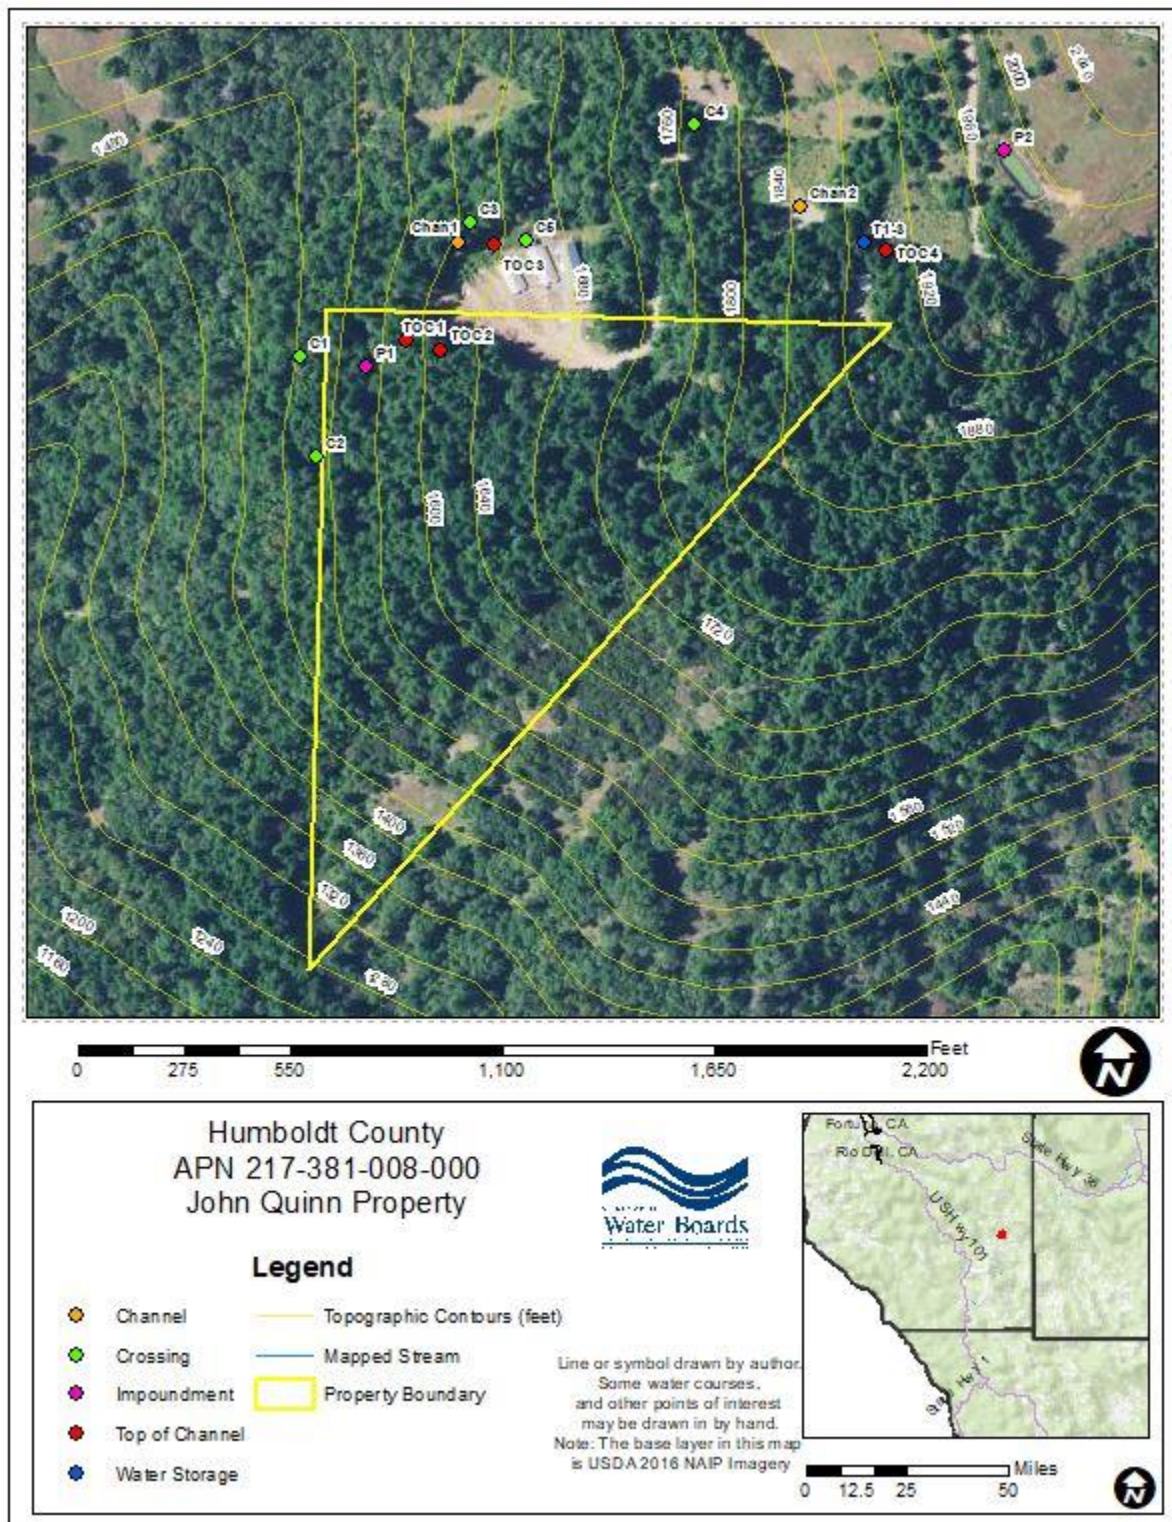
**Figure 1: Map of Property, including Inspection Points of Interest**

On June 21, 2019, I inspected the subject Property. Figure 1 above is a site map showing the inspection points discussed below. Development on the Property at the time of the inspection included one area that was actively being used for cannabis cultivation and three areas that were previously used for cannabis cultivation (not labeled on Figure 1), water supply infrastructure used for irrigating cannabis plants, including an off-stream impoundment, an onstream impoundment that was not actively being used for cannabis irrigation, as well as a network of connecting roads and related road infrastructure, including five stream crossings.
